Bentonite Contamination in Plastic Pipe Installed by HDD

Manager, Distribution Integrity Management PG&E

Principal Engineer, Exponent Failure Analysis Associates

August 28, 2018

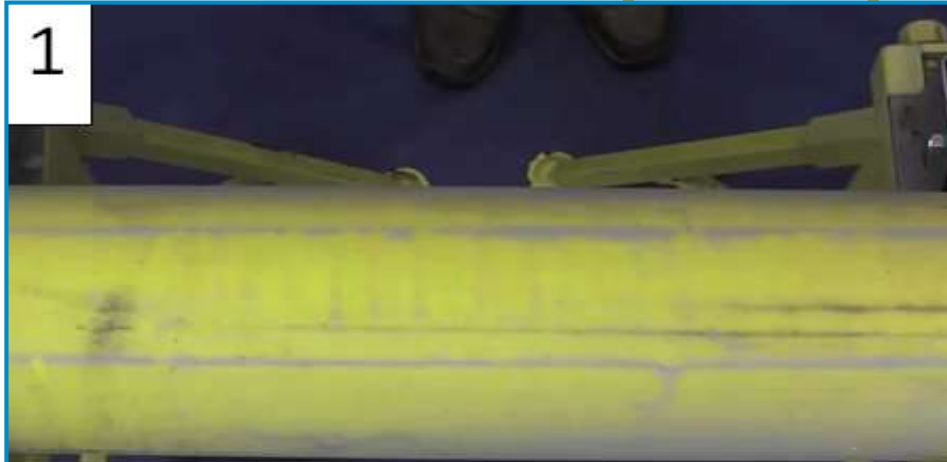
1 PE pipe contaminated with drilling mud

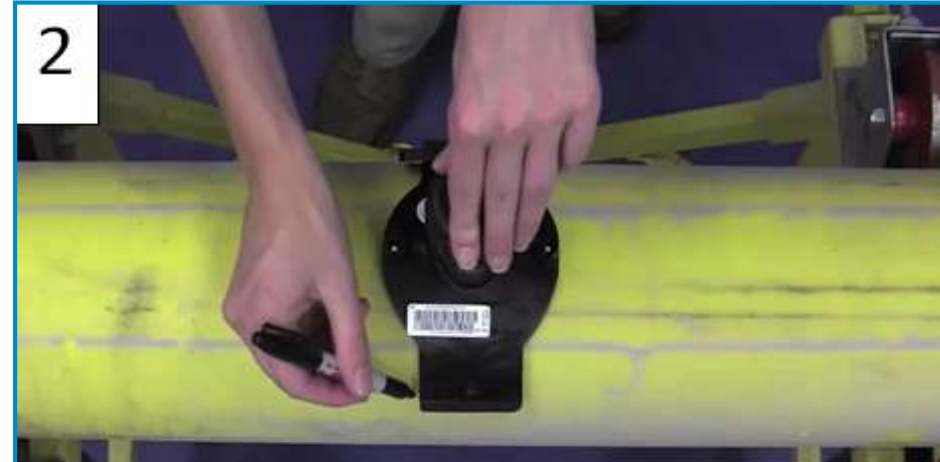
2 Establishing the fusion/scraping zone

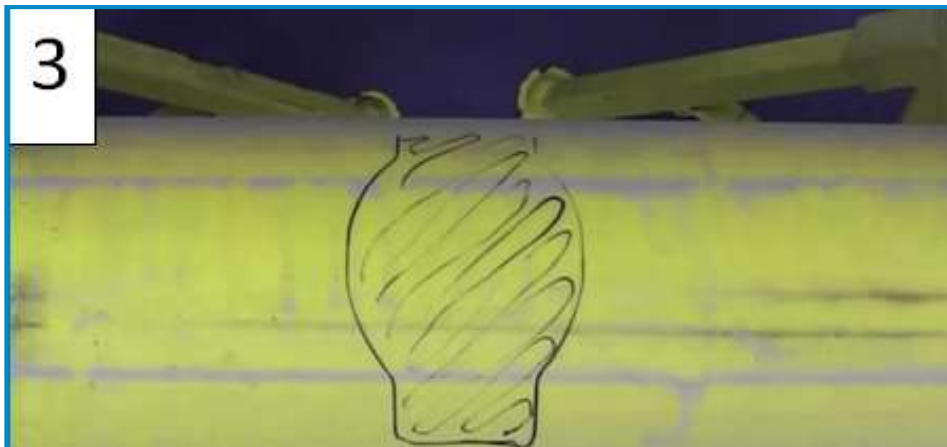
3 Fusion zone highlighted

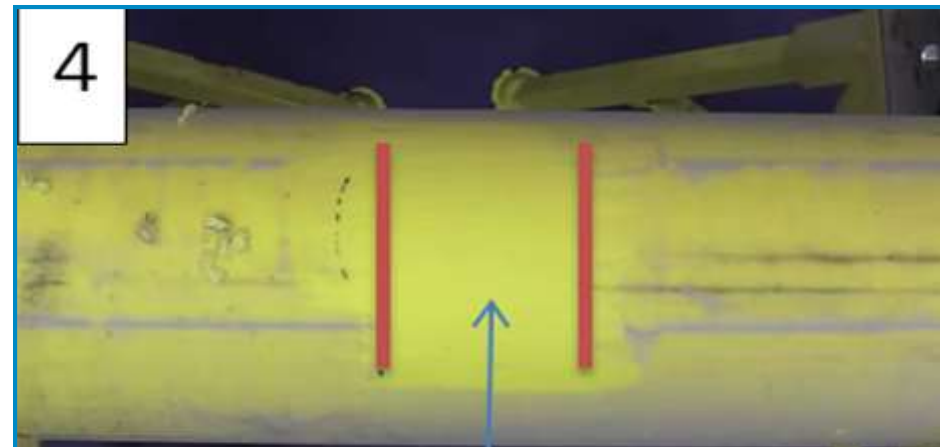
4 Cleaned and scraped area

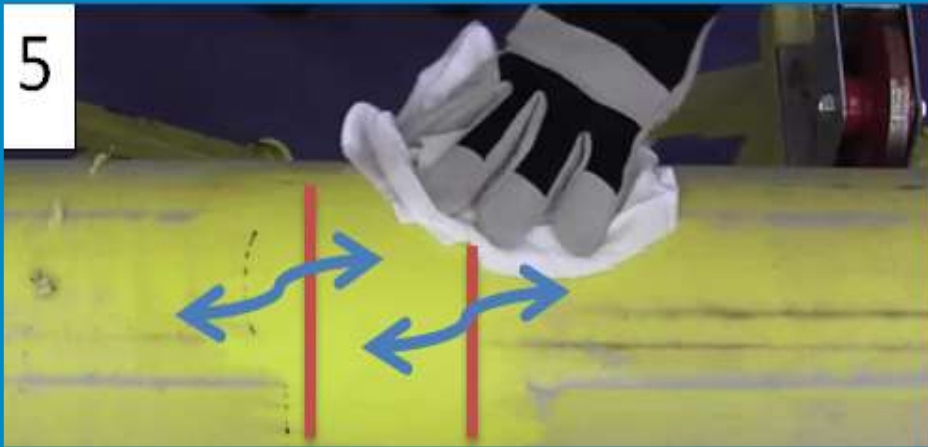
5
Unknowingly moving contaminant into the scraped/clean zone while applying alcohol

- Revised Electrofusion connection procedures to improve the cleaning process
 - Added required cleaning area for fusion area
 - Established a “clean zone”, maintained throughout the fusion procedure

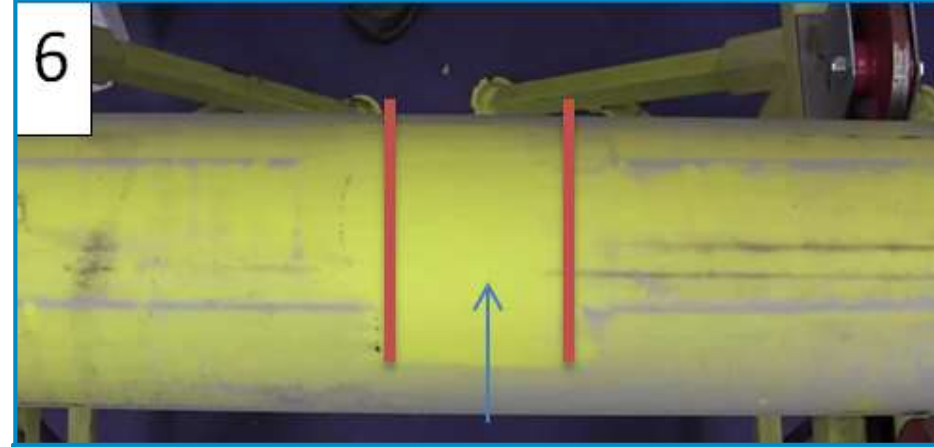
6
Clean and seemingly decontaminated fusion zone

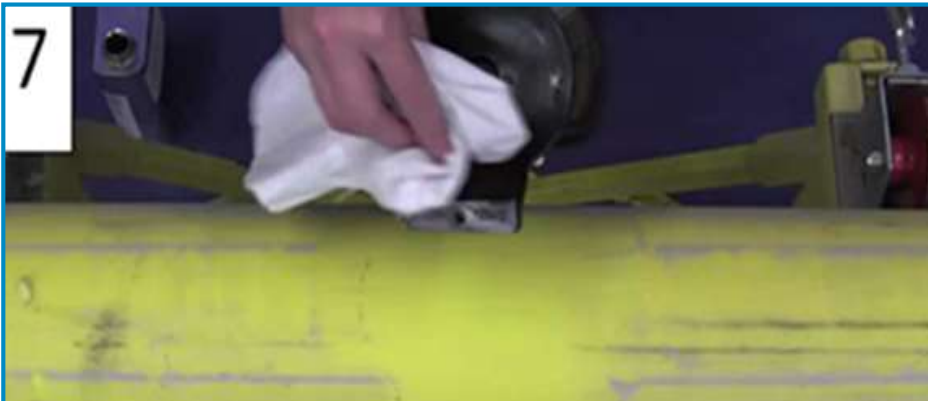
7
Often, the same cloth is used to clean the PE pipe and electrofusion saddle fitting

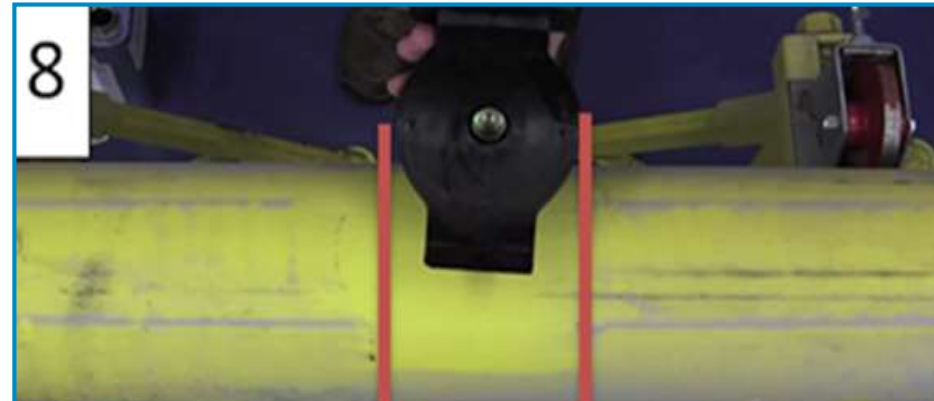
8
Presence of film of contamination on what appears to a clean pipe and fitting

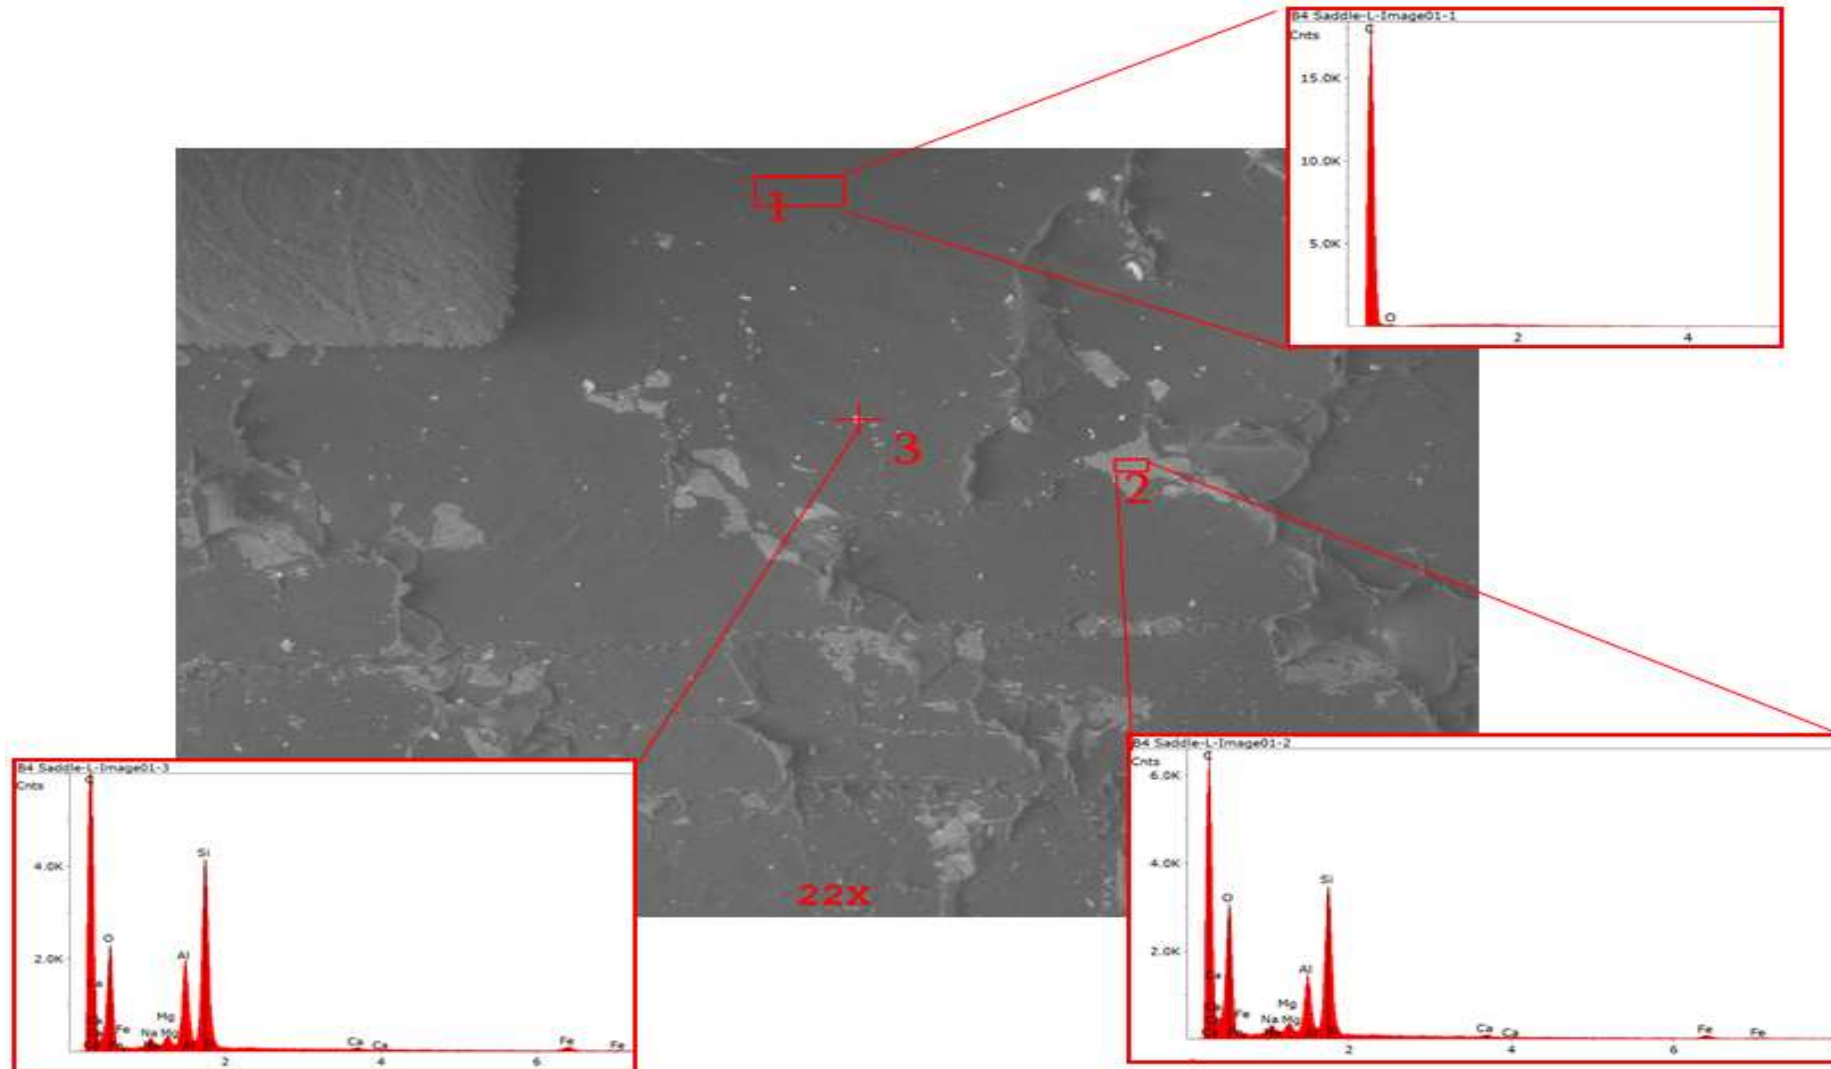
Failed Joint SEM/EDS Test Result

- Si, Al, Ca, Mg, Fe, Na are “fingerprints” of bentonite contamination.
- Native soil with these elements was not nearly as potent as bentonite in reducing fusion integrity.

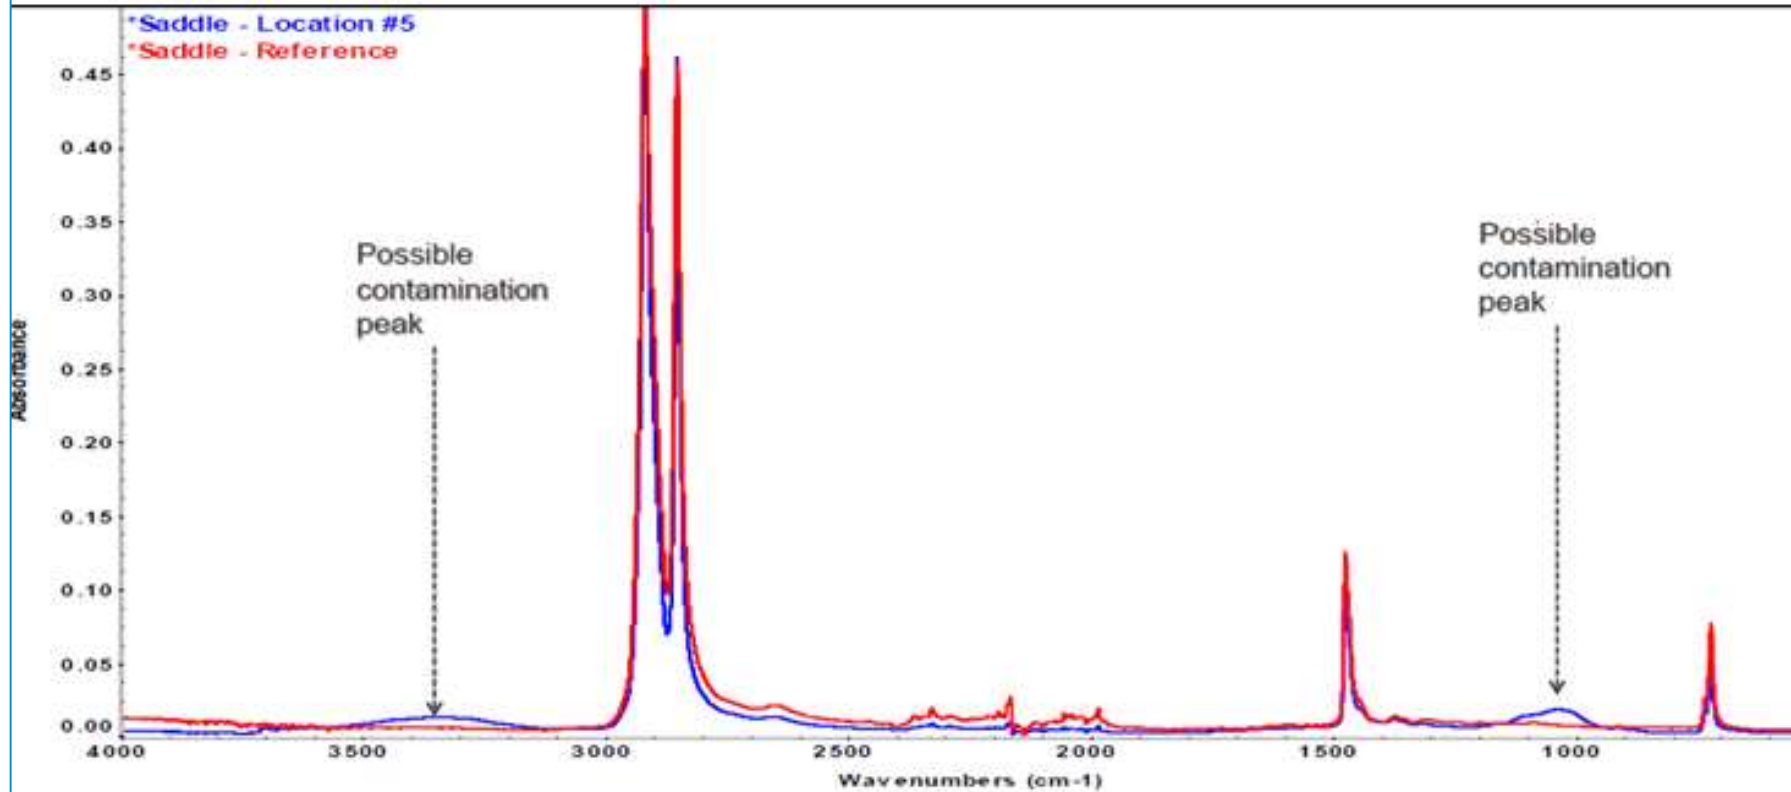
Failed EF Fitting Sample collected From the Field FTIR Graph

- Lab experiments including SEM/EDS and FTIR evaluations concluded drilling mud contamination as the cause of failures

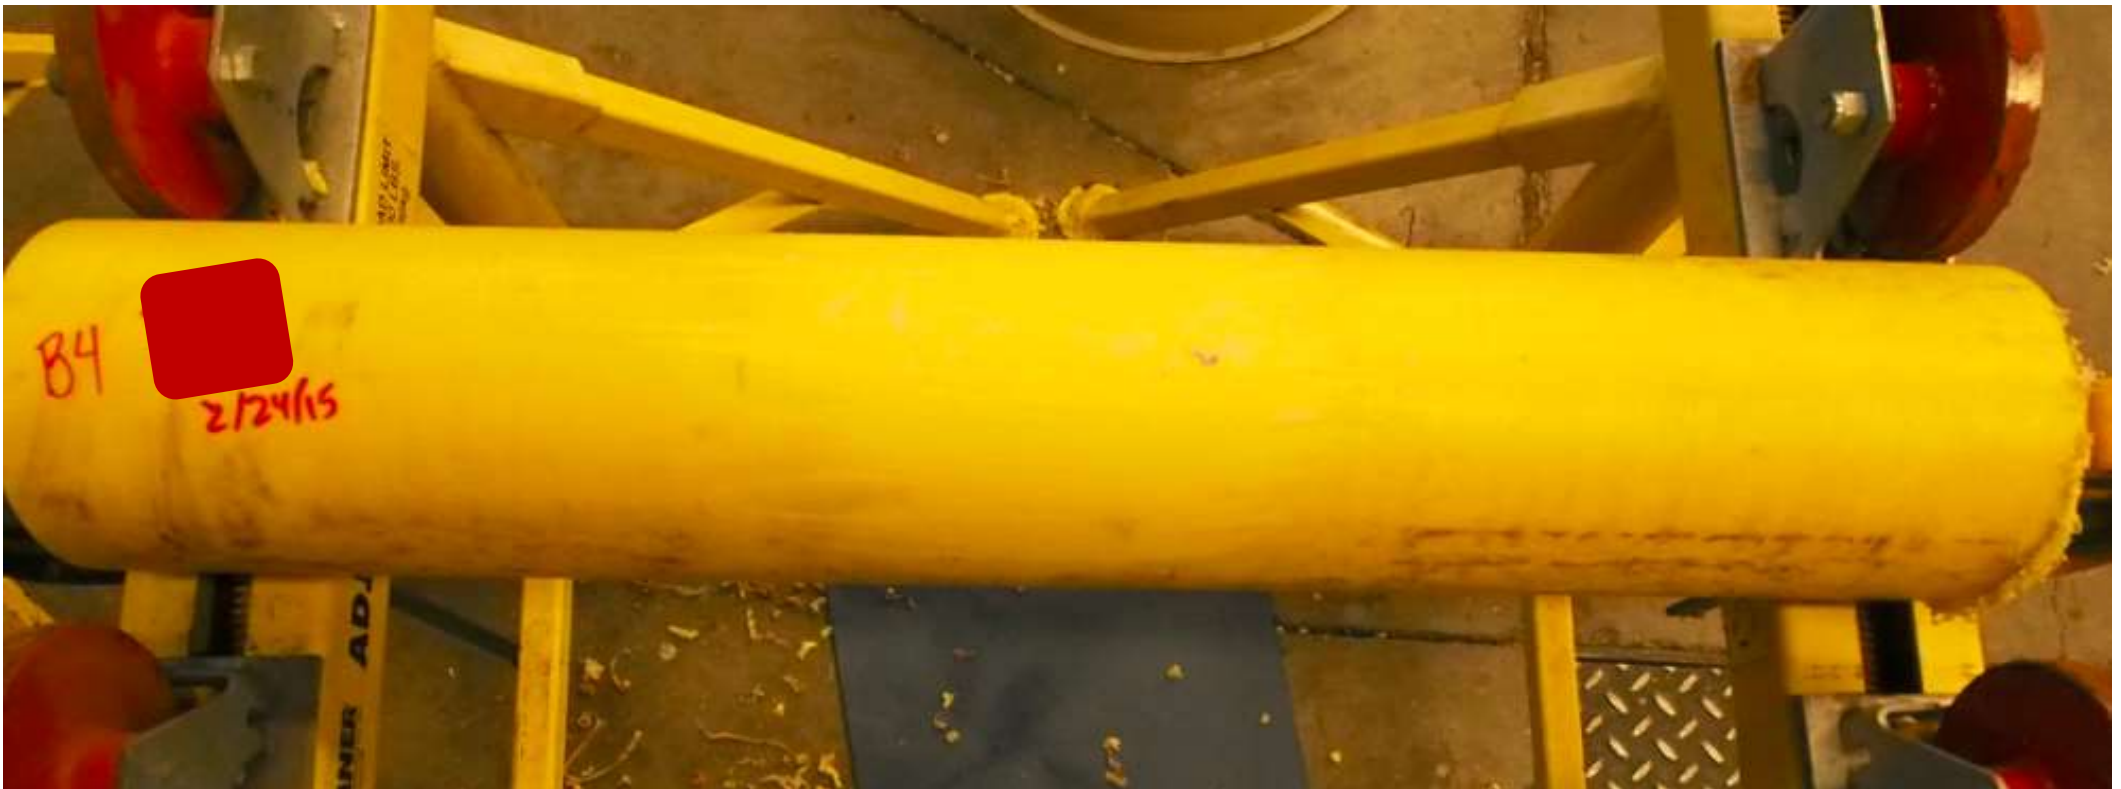
- Exponent's laboratory testing shows that even an invisible film of bentonite contamination blocks proper EF joint formation.
