Well Casing Cathodic Protection - Design Issues, Lessons Learned and a Case History

Jeffrey L. Didas
Matcor, Inc.
101 Liberty Lane
Chalfont, PA 19111
USA

WRGC – Western Regional Gas Conference 2018
Henderson, NV USA

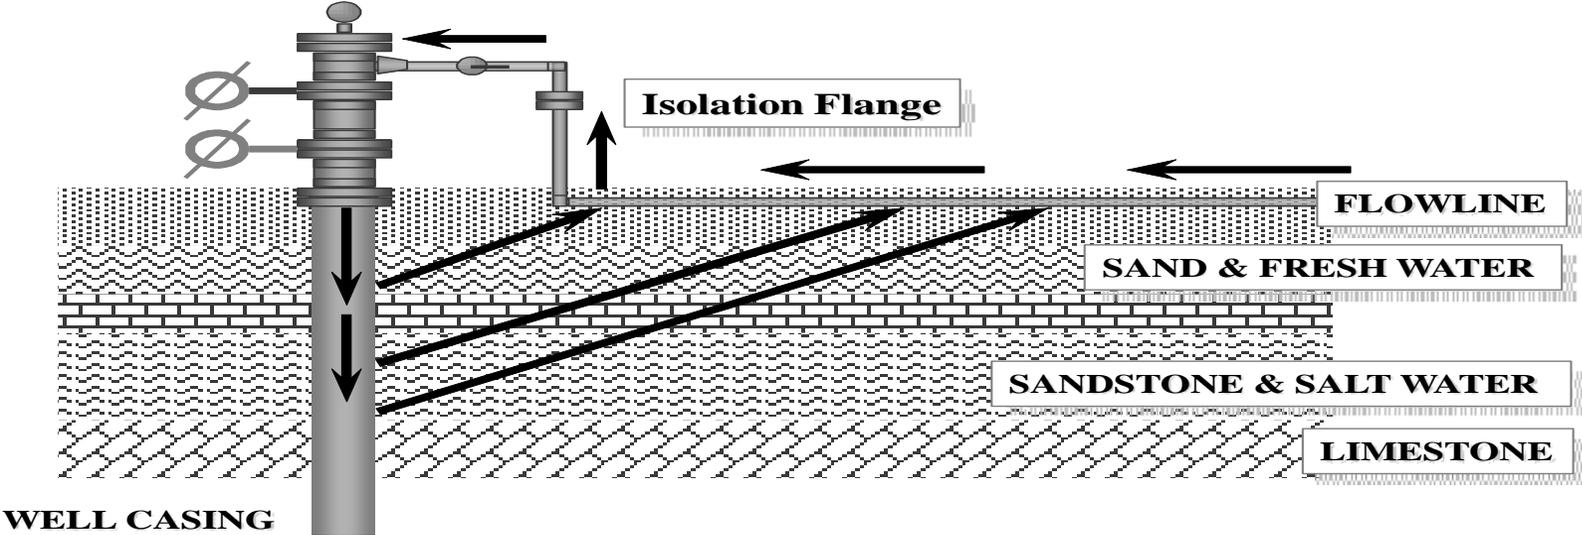
Typical Wellhead – Well Casing

Electrical continuity of the surface casing, production casing, tubing, etc. Electrical continuity between the well components at the wellhead is also critical as this will minimize CP current passing between the components downhole. Electrical continuity at the wellhead and a separate negative cable at the wellhead will allow the majority of the CP current to travel up the casing and to the negative return.

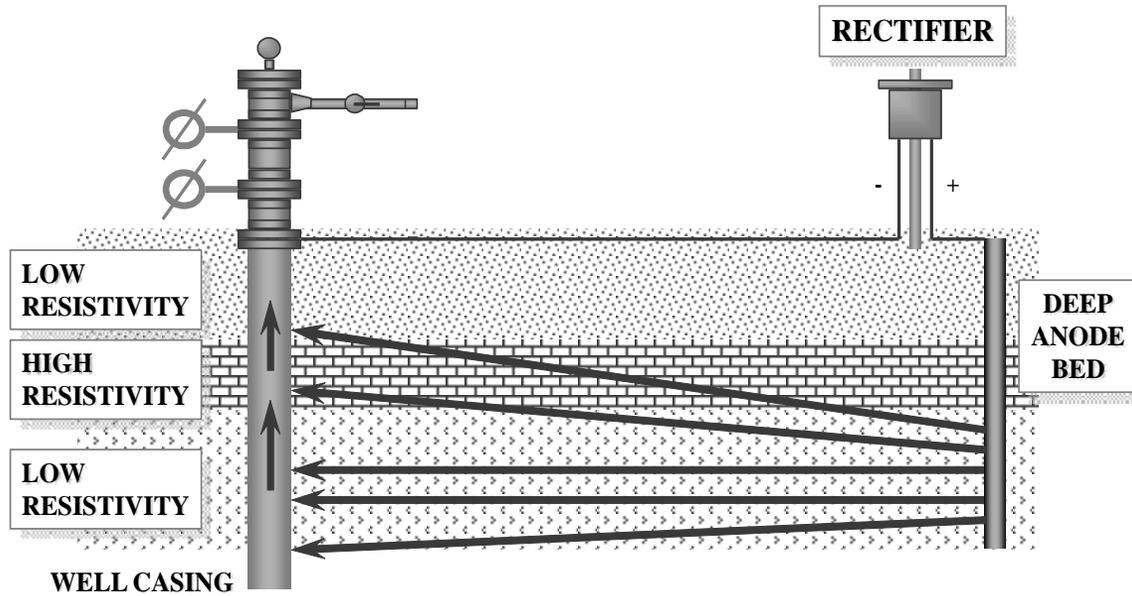
Current Distribution – Deep Anode Bed

Well casings are typically protected with an impressed current CP system – either a remote surface anode bed or a deep anode. The optimum location for the surface anode bed/deep anode is at remote earth. At remote earth, the anode bed/deep anode provides the best current distribution for the entire well casing. If installed too close to the well casing, then poor current distribution will result. Typically, remote earth is obtainable at approximately 500 feet from the structure.

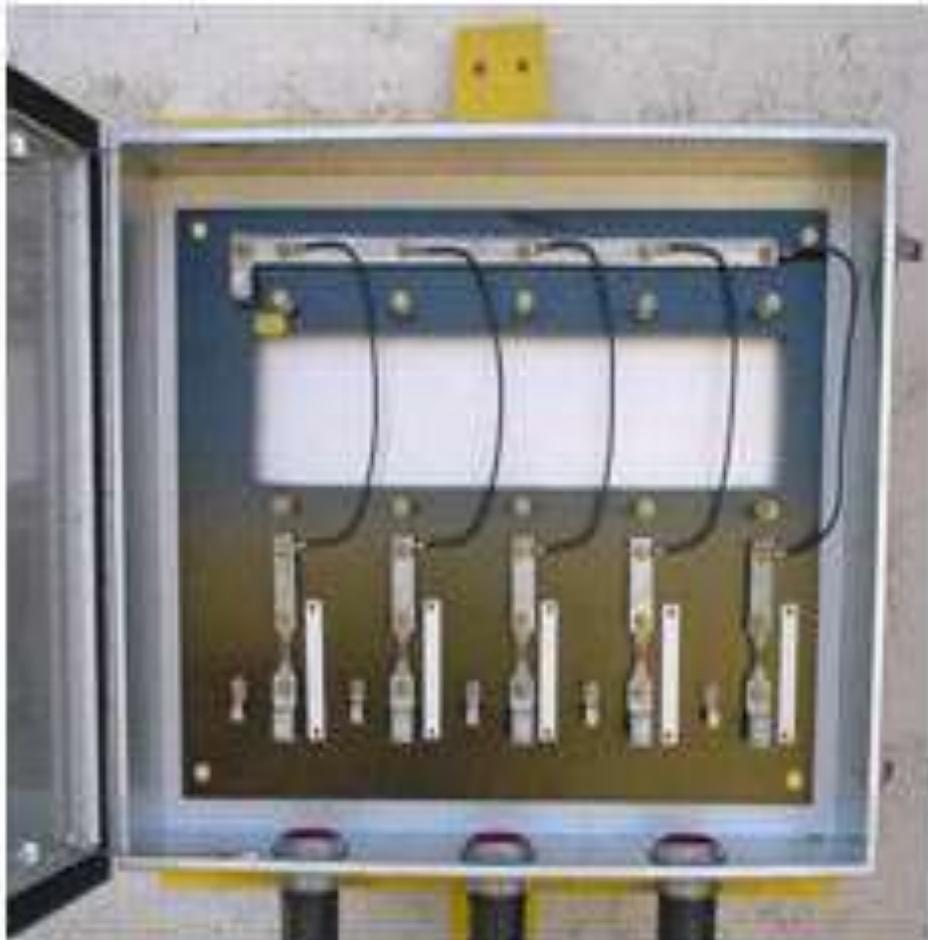
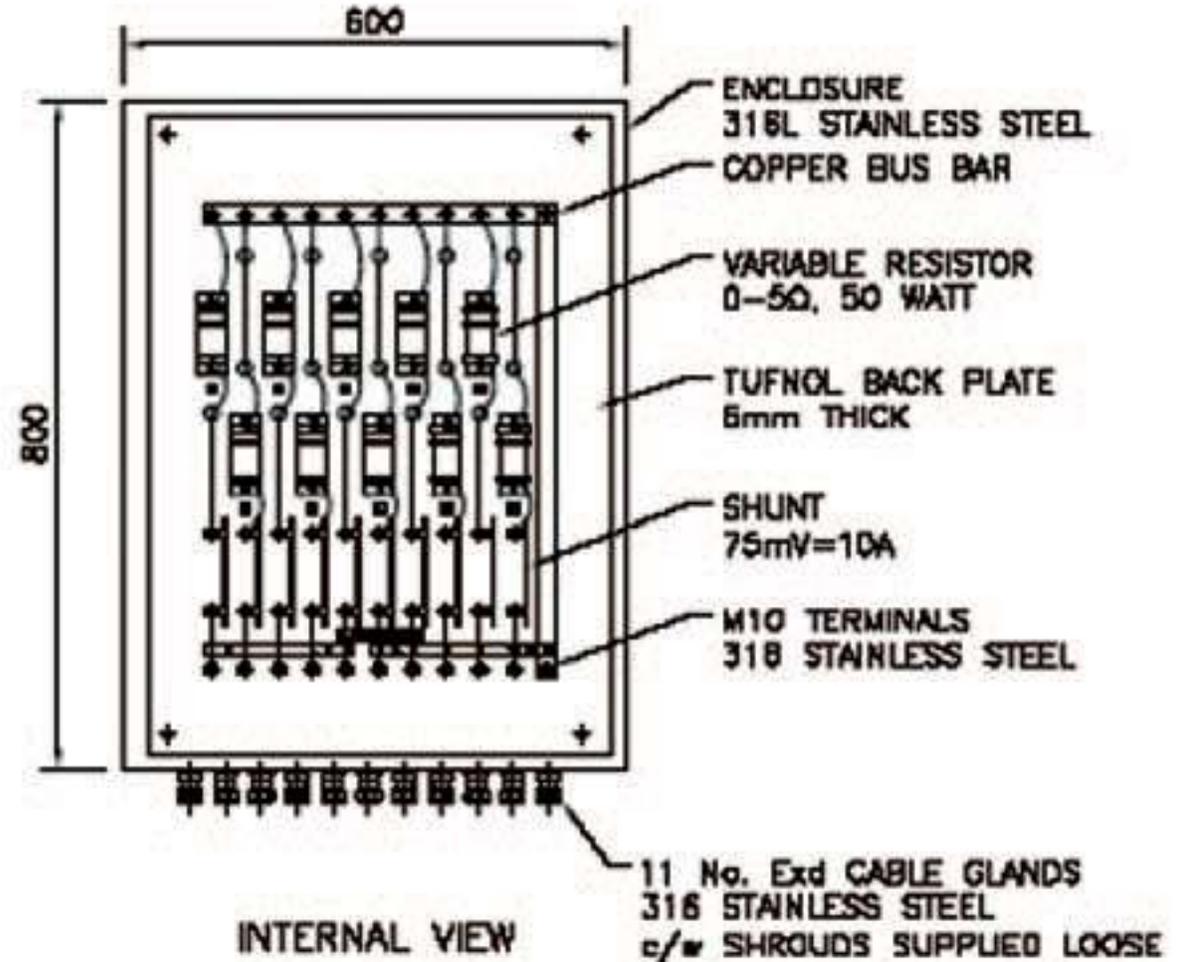
Typical Negative Control Boxes

After a few months, the corrosion technician and the contract corrosion engineer evaluated the CP system at the four well pad and realized they had quite an imbalance in the negative return current and two of the well casings were not receiving adequate CP current. A decision was made to install a negative control box and replace the negative junction box. A negative control box is basically a negative junction box with resistors installed for each circuit. The rectifier was also adjusted to a DC output of 44 amperes.

The negative control box was installed and resistance was added to the well #1 negative return and the current flow reduced from 22 amperes to 11 amperes.

Six months later well #1 had a leak. The well was shut in and the tubing and casing pulled and a 100-foot section of the casing was found to have severe pitting corrosion. The cause appeared to be the CP current was discharging from well #1 to wells #3 & #4 through the soil. This location had a fairly low resistance formation and the CP current was flowing through that path to return the CP current to the rectifier. The path had a much lower resistance than the resistance of the control box resistor.

Do not install too much resistance in a CP circuit as the CP current will always find the lowest resistance path back to the current source.

Solution that was designed and commissioned by the new contract corrosion engineer was to install a new deep anode at remote earth from the wellheads – approximately 500 feet away. The deep anode was installed at a depth of 400'. The negative control box and the existing deep anode was abandoned and a new negative junction box installed at the rectifier with NO resistors.
