Bentonite Contamination in Plastic Pipe Installed by HDD

Manager, Distribution Integrity Management PG&E

Principal Engineer, Exponent Failure Analysis Associates

August 28, 2018

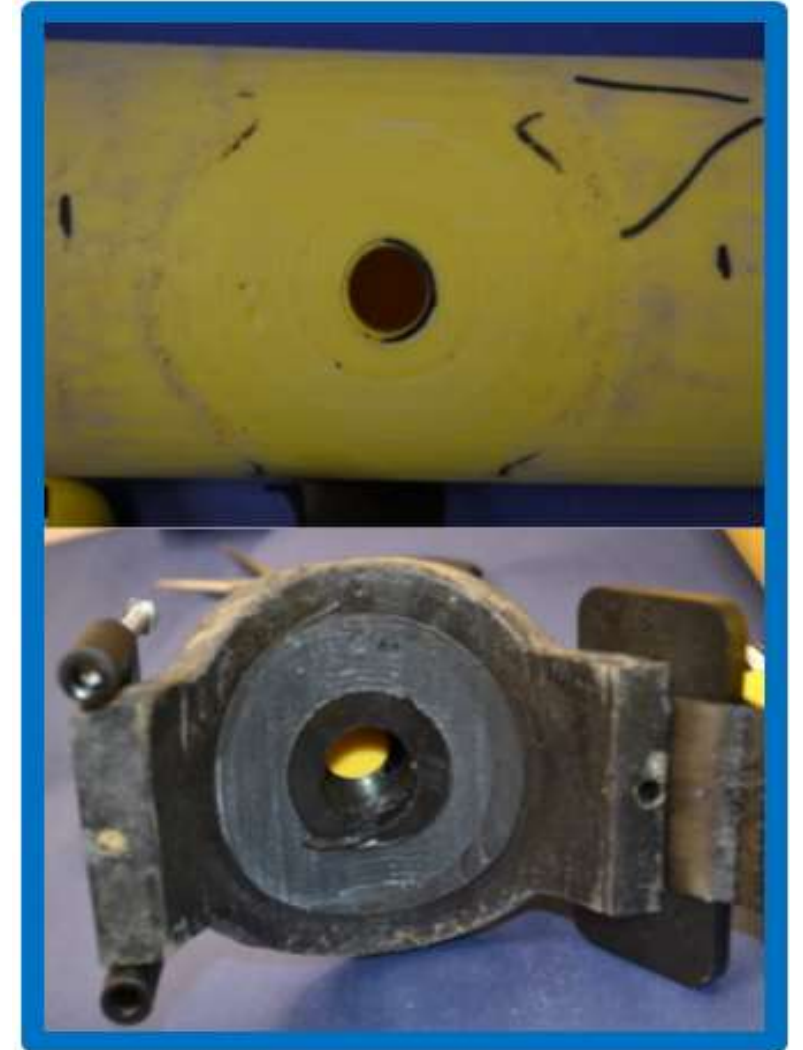
- In 2014, 3 electrofusion tapping tee failures were reported to DIMP engineering through the material problem report (MPR) process
- Initial inspection revealed contamination and poor scraping on the material fusion zone
- DIMP requested samples to be dug-up from the jobs where the failed fittings were located
- Out of 7 samples collected from the 3 jobs, 4 failed bend tests
- Following these tests PG&E retained Exponent

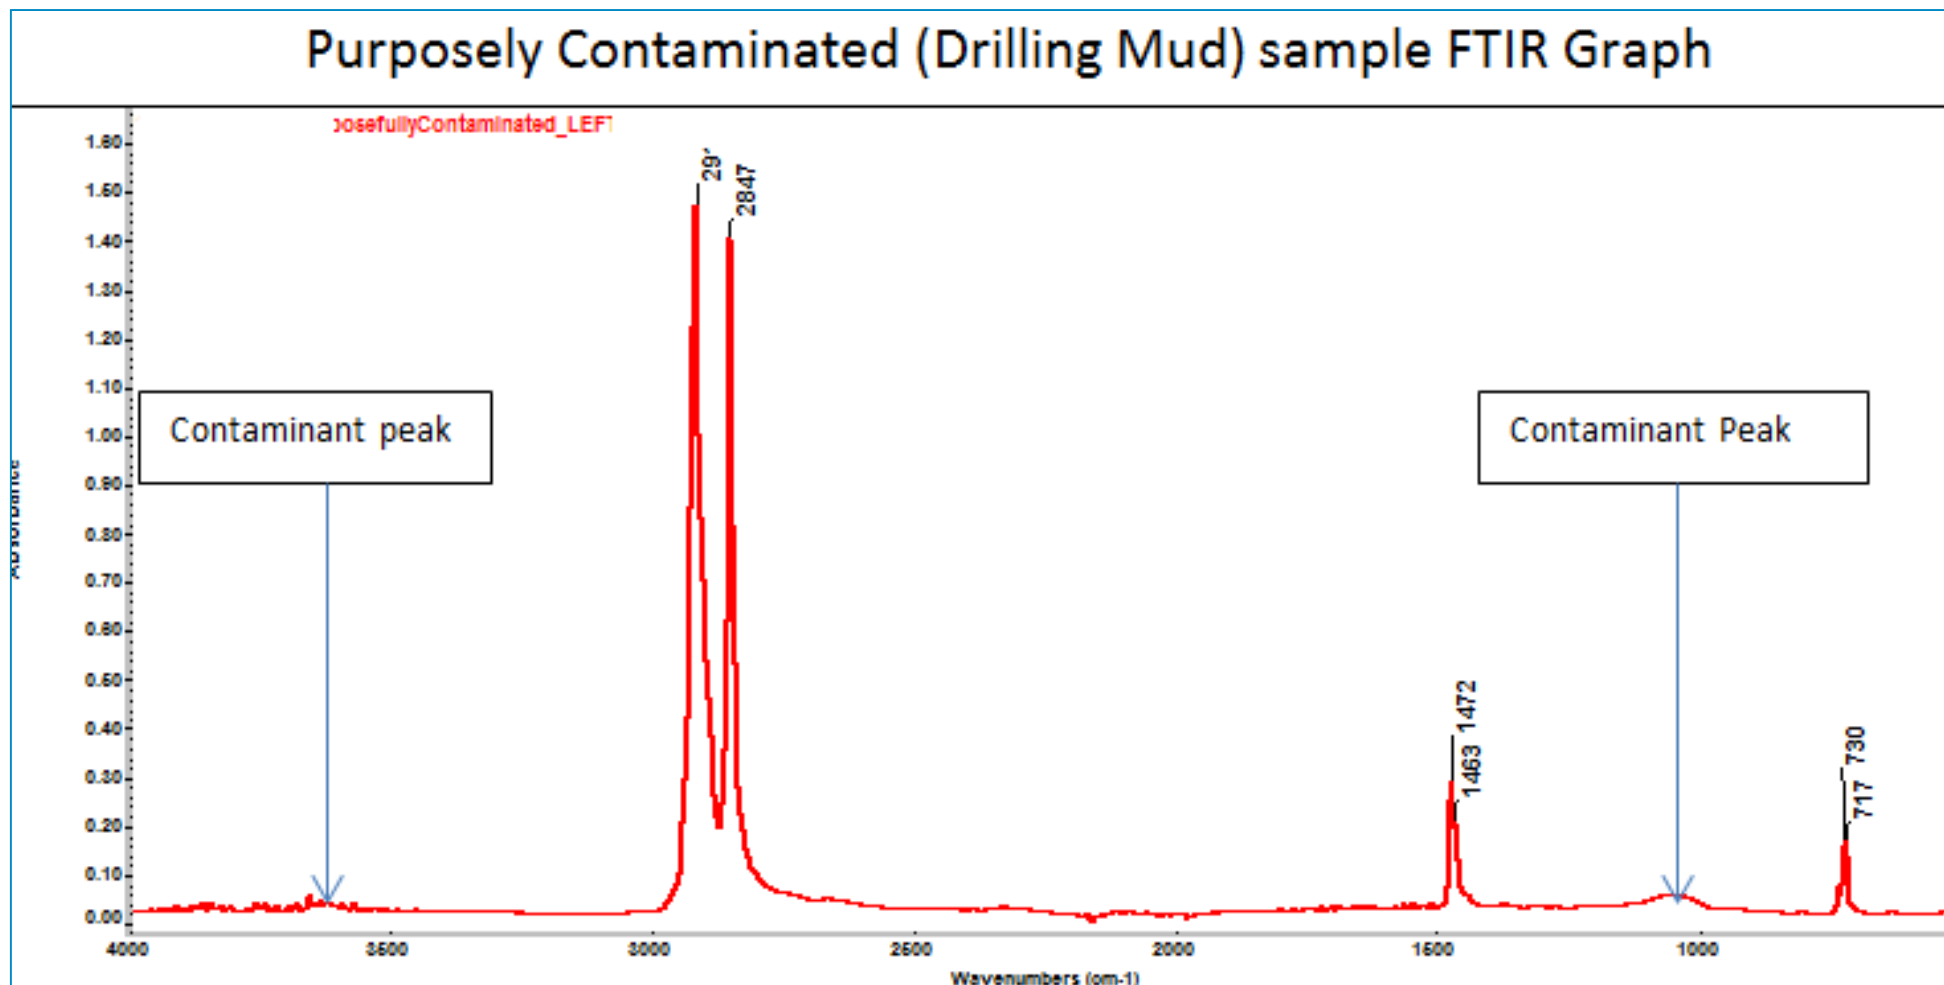
Drilling Mud “Samples” FTIR Test

- Lab experiments including SEM/EDS and FTIR evaluations concluded drilling mud contamination as the cause of failures

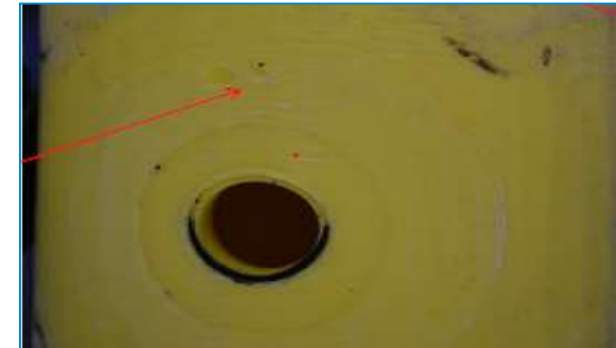
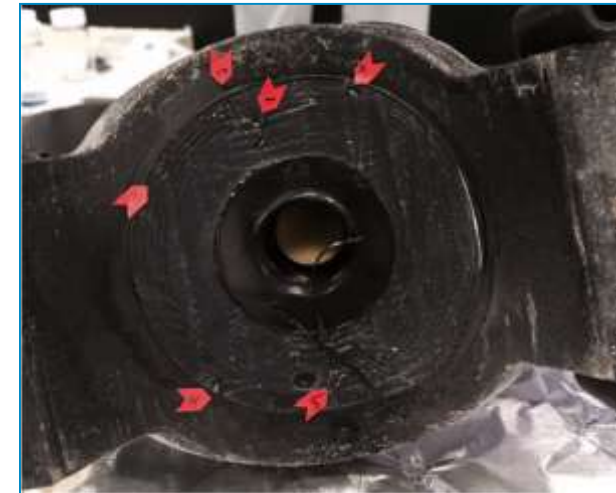
Failed EF Sample FTIR Test

Failed EF Fitting Sample collected From the Field FTIR Graph
