Updates on CA Pipeline Safety Program

Kenneth Bruno
Program Manager – Gas Safety Branch
Safety and Enforcement Division
California Public Utilities Commission

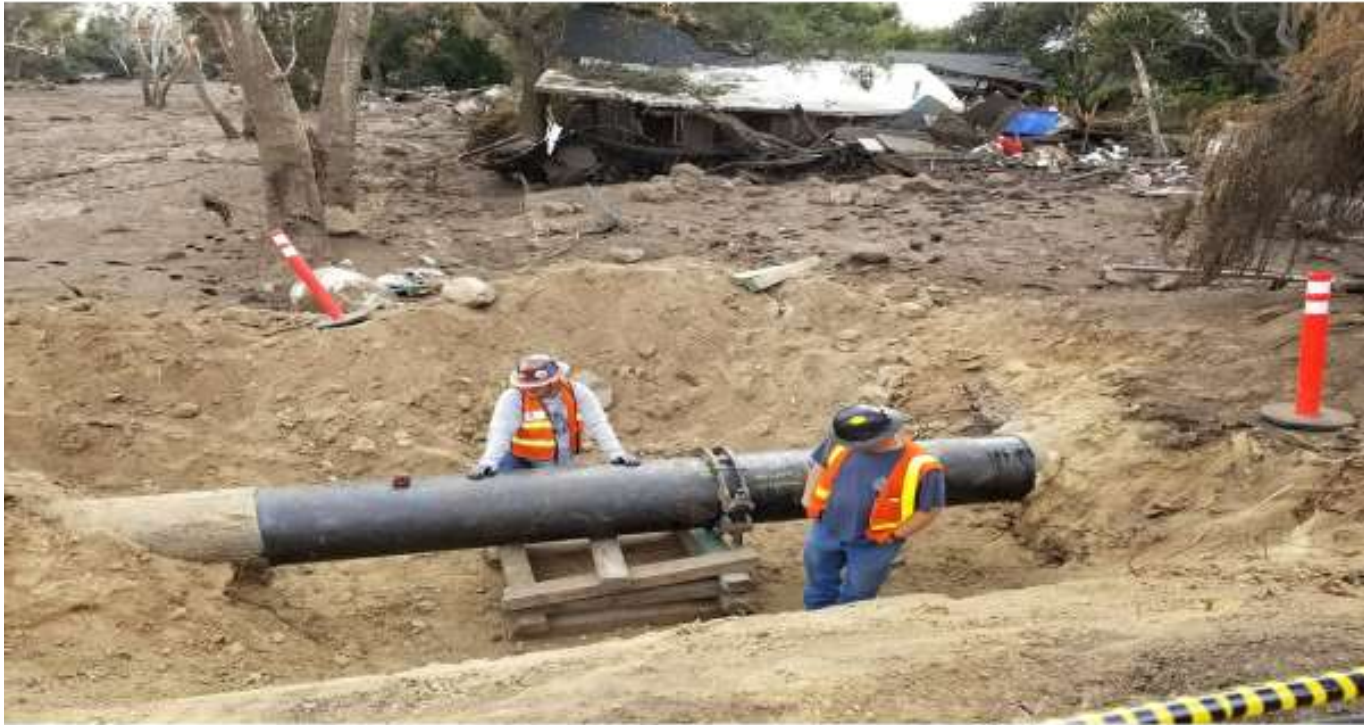
SoCalGas crew inspects gas line in area heavily impacted by mudslides.

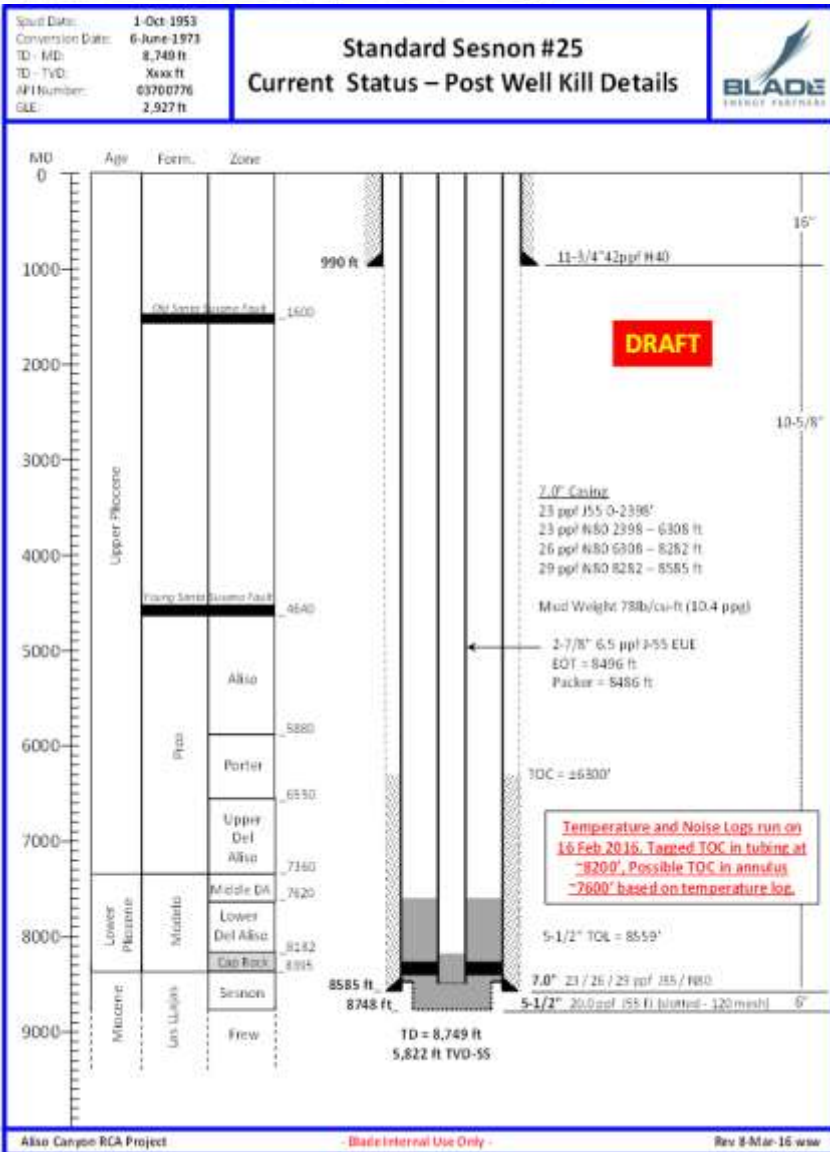
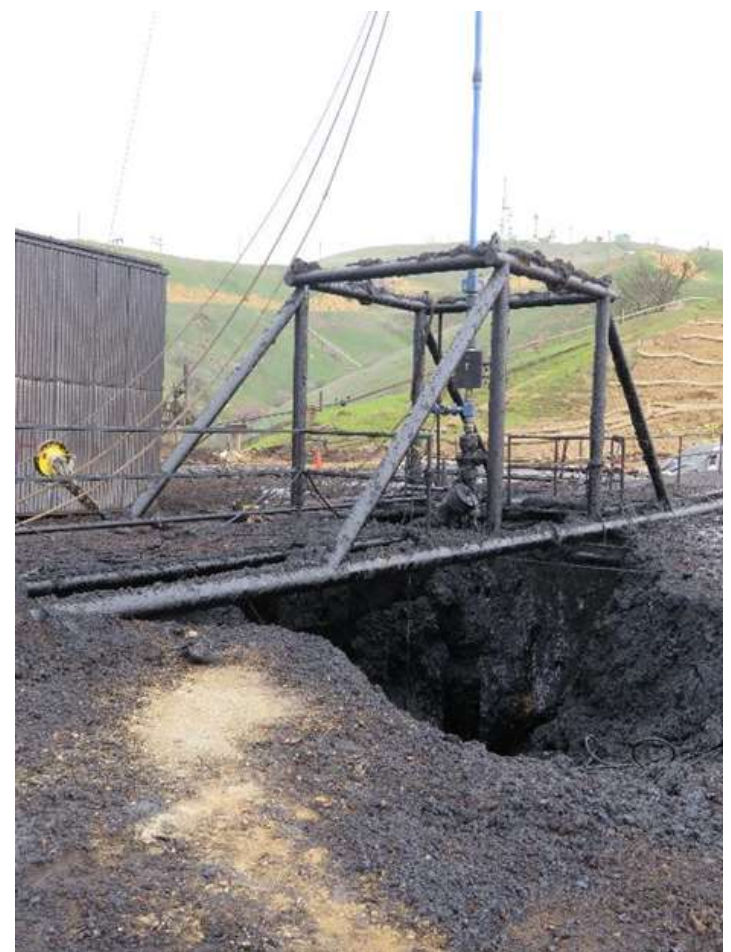
Aliso Canyon RCA update from Blade Energy Partners

Up to 60 metric tonnes/hr of methane*

- ❖ Root Cause and Contributing factors
 - Initial leak on SS 25
 - Initial leak growing to a larger leak; and then transitioning to a full fledged blow out.

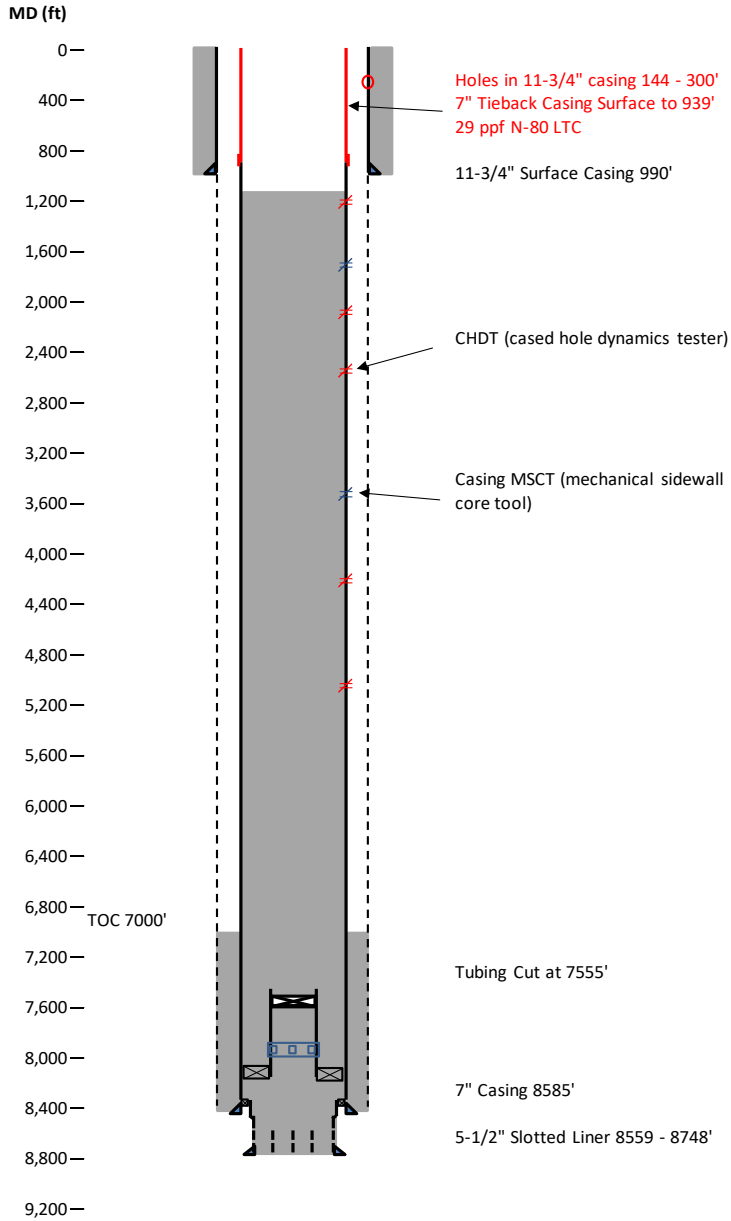
Standard Sesnon (SS-25) Wellbore (Proposed)

- ❖ Recovered 2 7/8" tubing.
- ❖ Recovered the 7" casing along with failure region.
- ❖ Recovered 7" from 939' to 1024' across the shoe to obtain remaining externally corroded 7"
- ❖ Ongoing:
 - 11 3/4" logging/camera/sampling

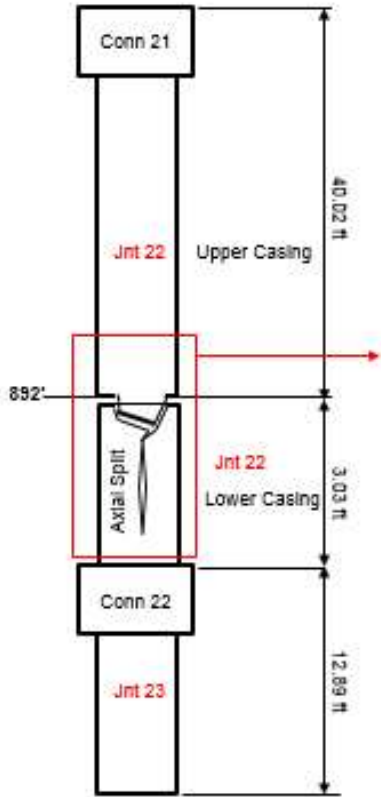
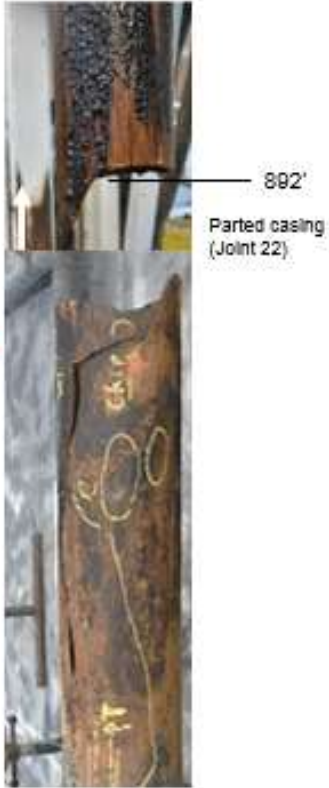
(a) Joint 2 (20.1'-60.6') showing little corrosion

(b) Joint 14 (517.8'-560.4') showing shallow corrosion

(c) Joint 20 (769.7'-810.6') showing a large area of deep corrosion

- ❖ 7" Casing failed at 892'
 - Casing parted circumferentially
 - Bottom part had an axial split
- ❖ 7" Casing corrosion observations
 - Based on visual observations, OD corrosion
- ❖ Beyond 1022' there appears to be no significant corrosion or anomalies
- ❖ 11-3/4" casing
 - Through wall metal loss (holes) starting around 150' to 300'

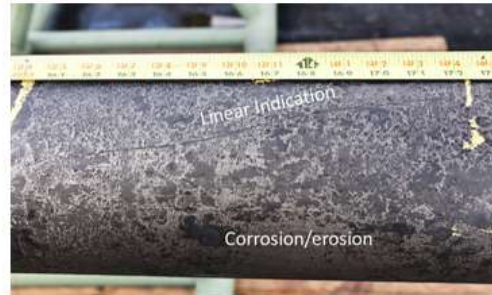
(a) Oblique Linear Indication on OD surface

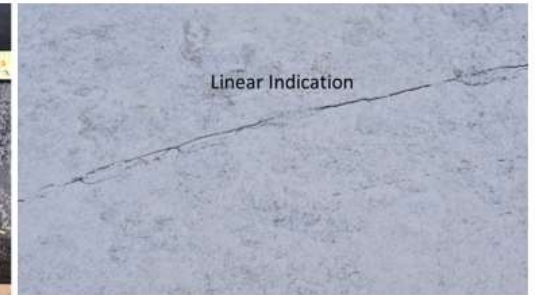
(b) Oblique Linear Indication showed by MPI
